Appendix B Revetments

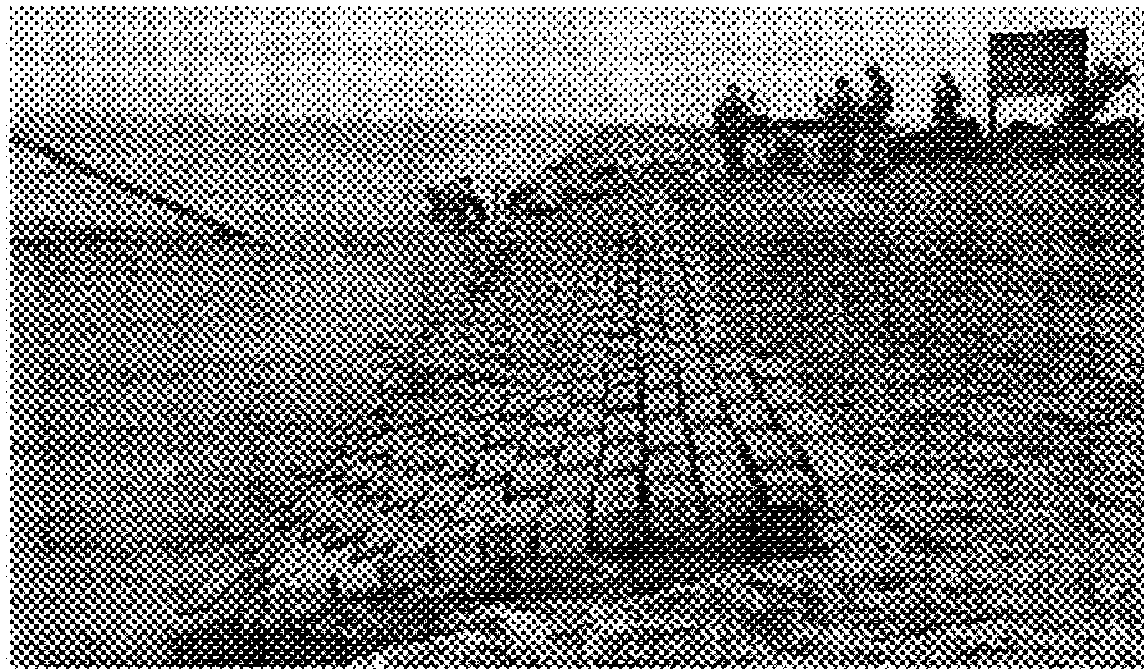
Figure B-30. Terrafix block revetment, Two Mile, FL

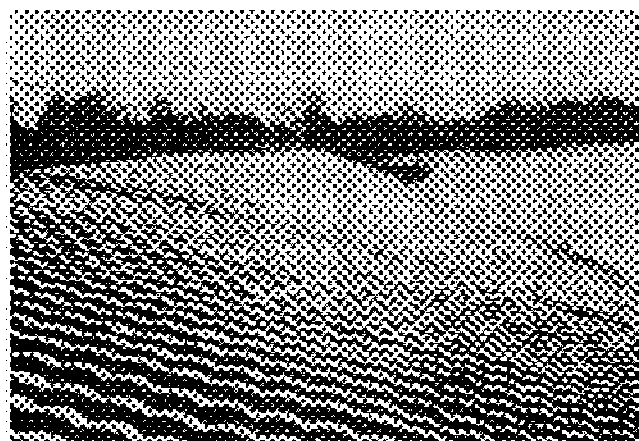
Figure B-32. Fabriform revetment, location unknown

c. Prototype installation (Figures B-32 and B-33). The best example of a concrete mattress subjected to wave action is the upstream face of Allegheny Reservoir

(Kinzua Dam) in northern Pennsylvania and southern New York. Built in 1968, the Fabriform nylon mat was placed 53 ft down a 1-on-1.5-slope and, through 1980, was functioning as designed. The panels were anchored in a trench about 7 ft above the high water level. A large portion of the lower part of the revetment was constructed with the nylon fabric forms under water. Because the mattress is essentially a collection of discrete concrete

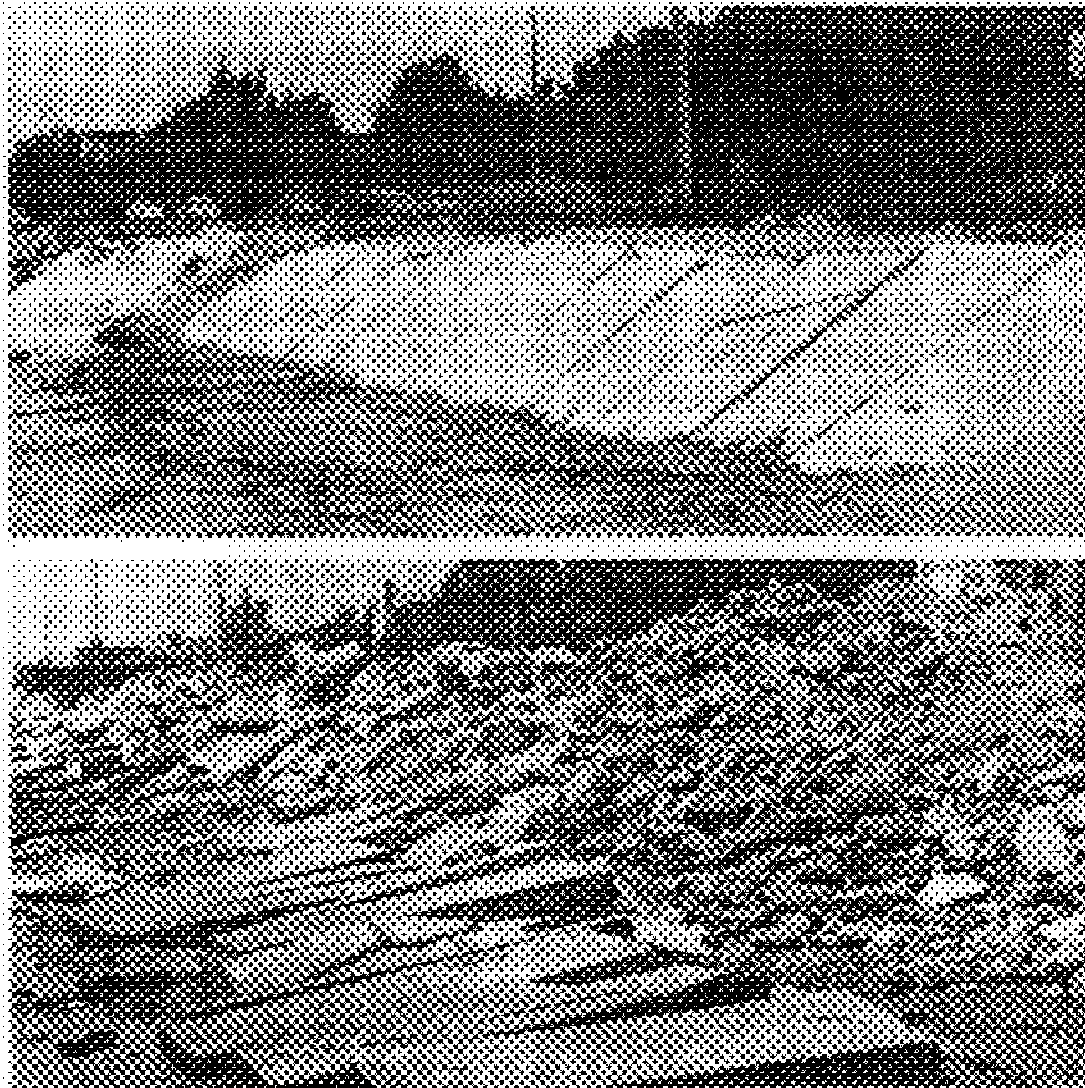
Figure B-42. Concrete slab revetment, Alameda, CA

c. Prototype installation (Figures B-42 and B-43). A concrete slab revetment constructed at Alameda, CA, in November 1978, is illustrative of the problems commonly experienced with this kind of structure (final report on Shoreline Erosion Control Demonstration Program). The structure was placed on a sand fill at a 1-on-0.6 slope with an underlying nonwoven filter cloth. The slabs, obtained from a building demolition site, were hoisted into place by crane; and one slab was cracked during this operation. The structure failed under wave action because of inadequate toe protection, flanking, failure of the filter cloth under the shifting slabs, and inherent instability of the underlying 60-deg slope.
